DEVELOPMENT OF REPAIR PROCESSES  
AND SOURCES FOR C/KC-135 AIRCRAFT  
WINDOWS/WINDSHIELDS

RICHARD J. OLSON

BATTELLE  
505 KING AVENUE  
COLUMBUS, OH 43201

SEPTEMBER 1994

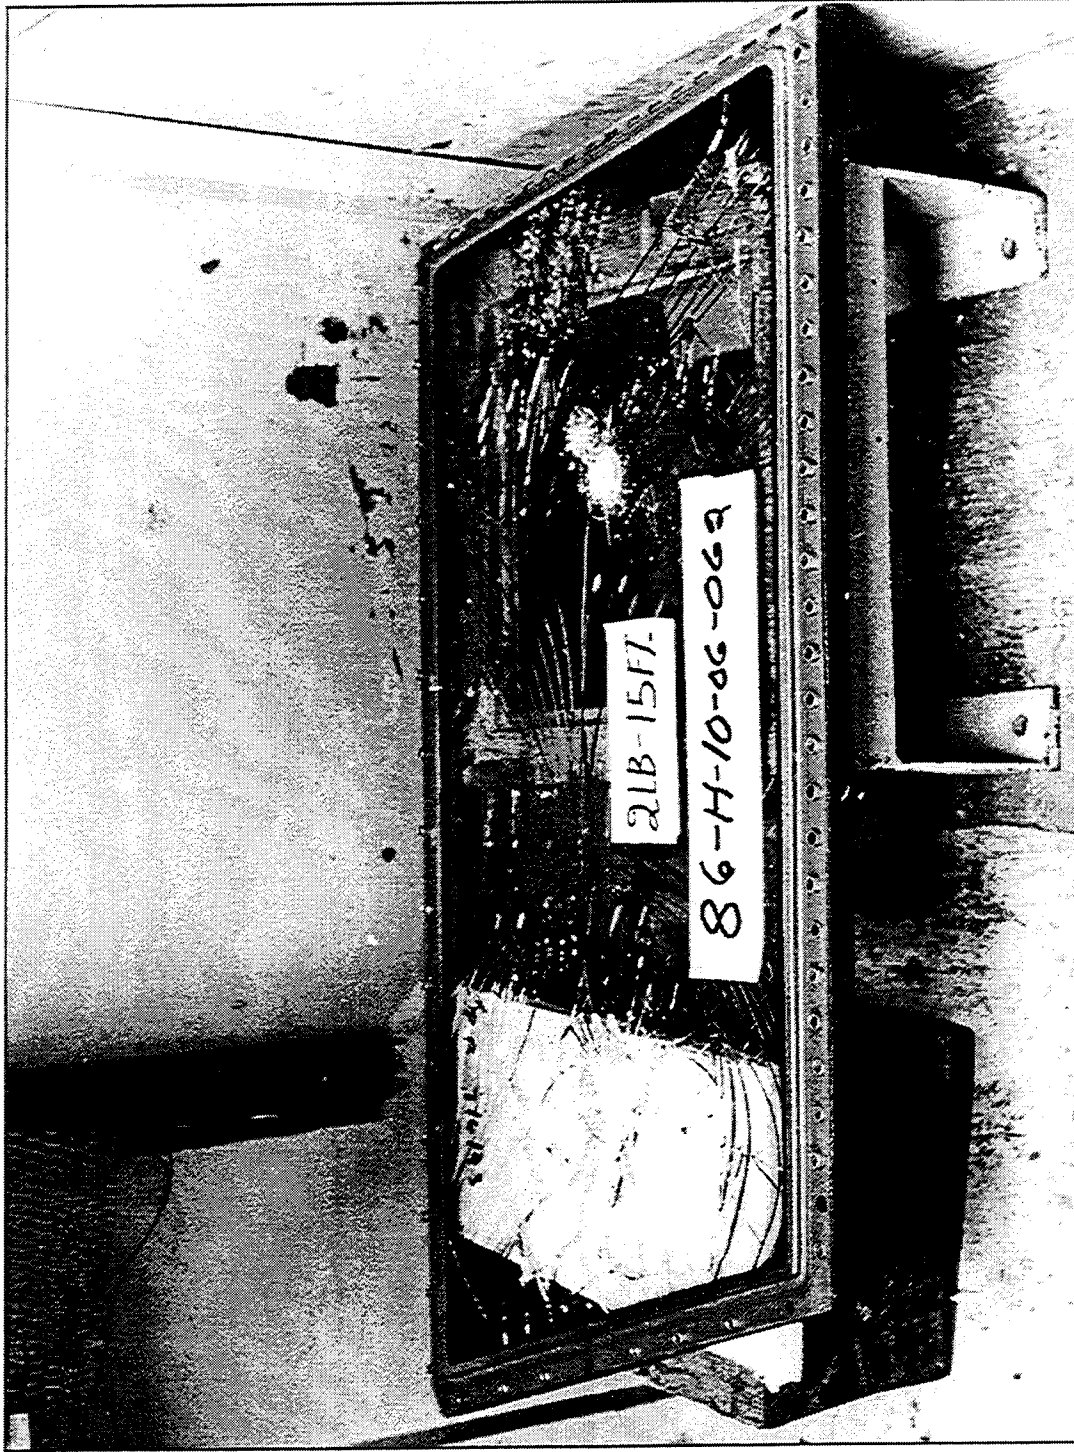
Tables 4.11 and 4.12 detail the results of the falling ball residual strength impact testing, while Figures 4.14 through 4.19 show the test set-ups and selected consequences of the impacts. The results of the ball drop are not conclusive because only a single new W/WS was tested of each type. The worst damage occurred in repaired W/WS with delamination, so there appears to be a suggestion that the ball drops do more damage to the repaired W/WS than the new W/WS.

Figure 4.14 #1 W/WS Residual Strength Falling Ball Impact Test Showing Test Set Up and Consequences of Two Ball Drops  
(New W/WS, S/N 86-H-10-06-062)

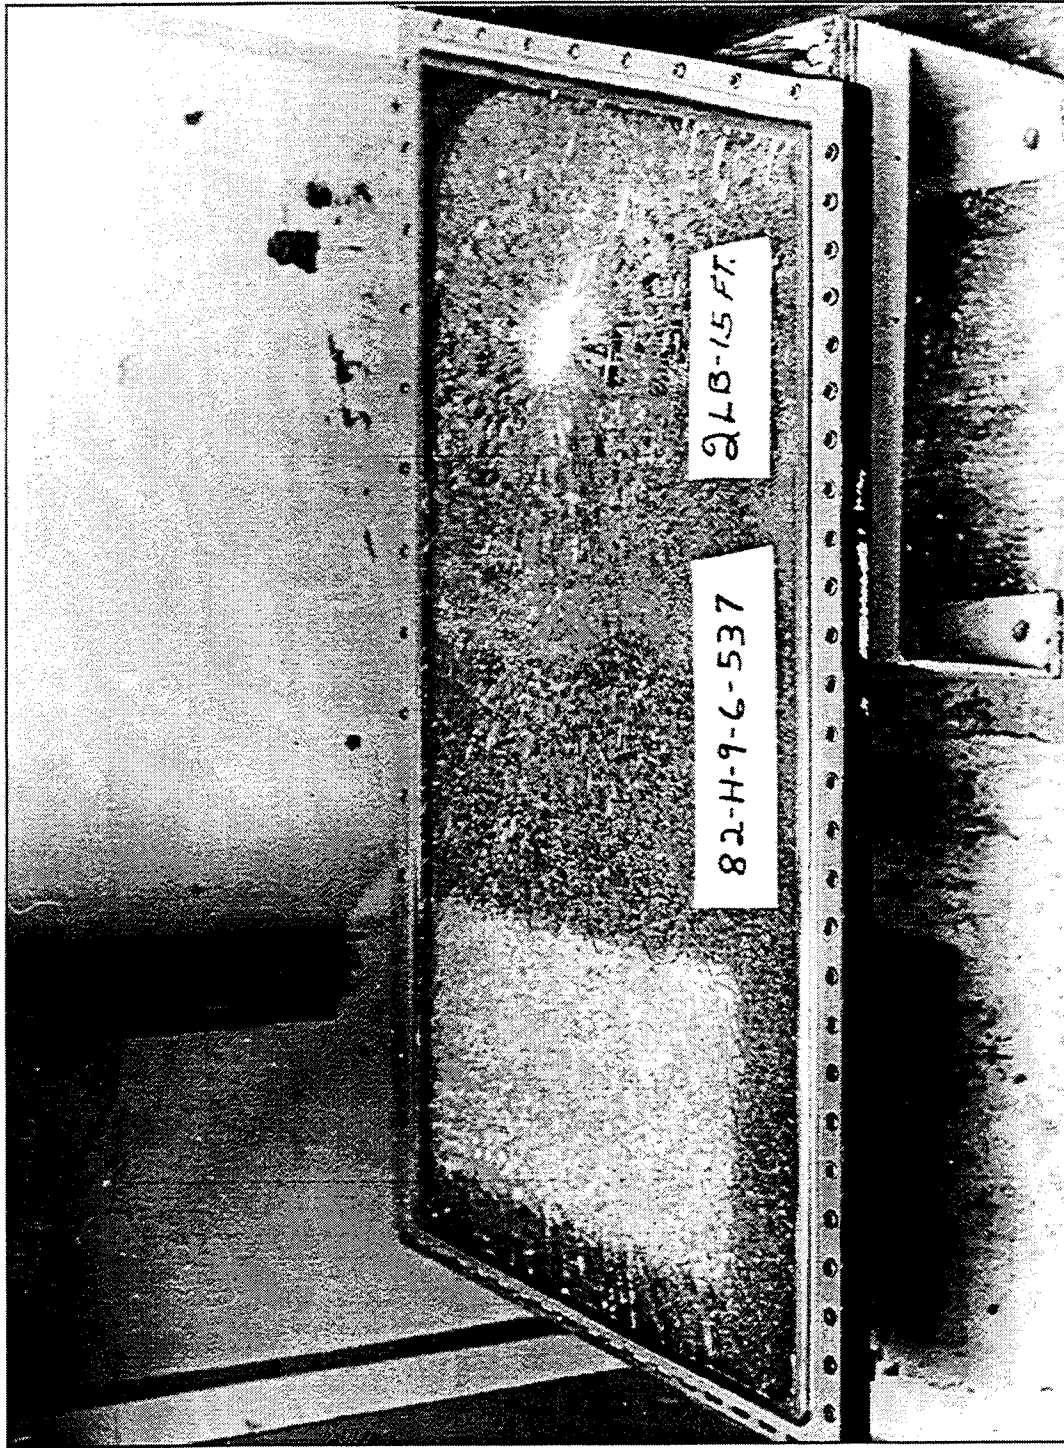
Figure 4.15 #1 W/WS Residual Strength Falling Ball Impact Test Result for a Repaired and Subsequently Delaminated W/WS, Single Ball Drop, Outboard View (S/N 82-H-9-6-537)

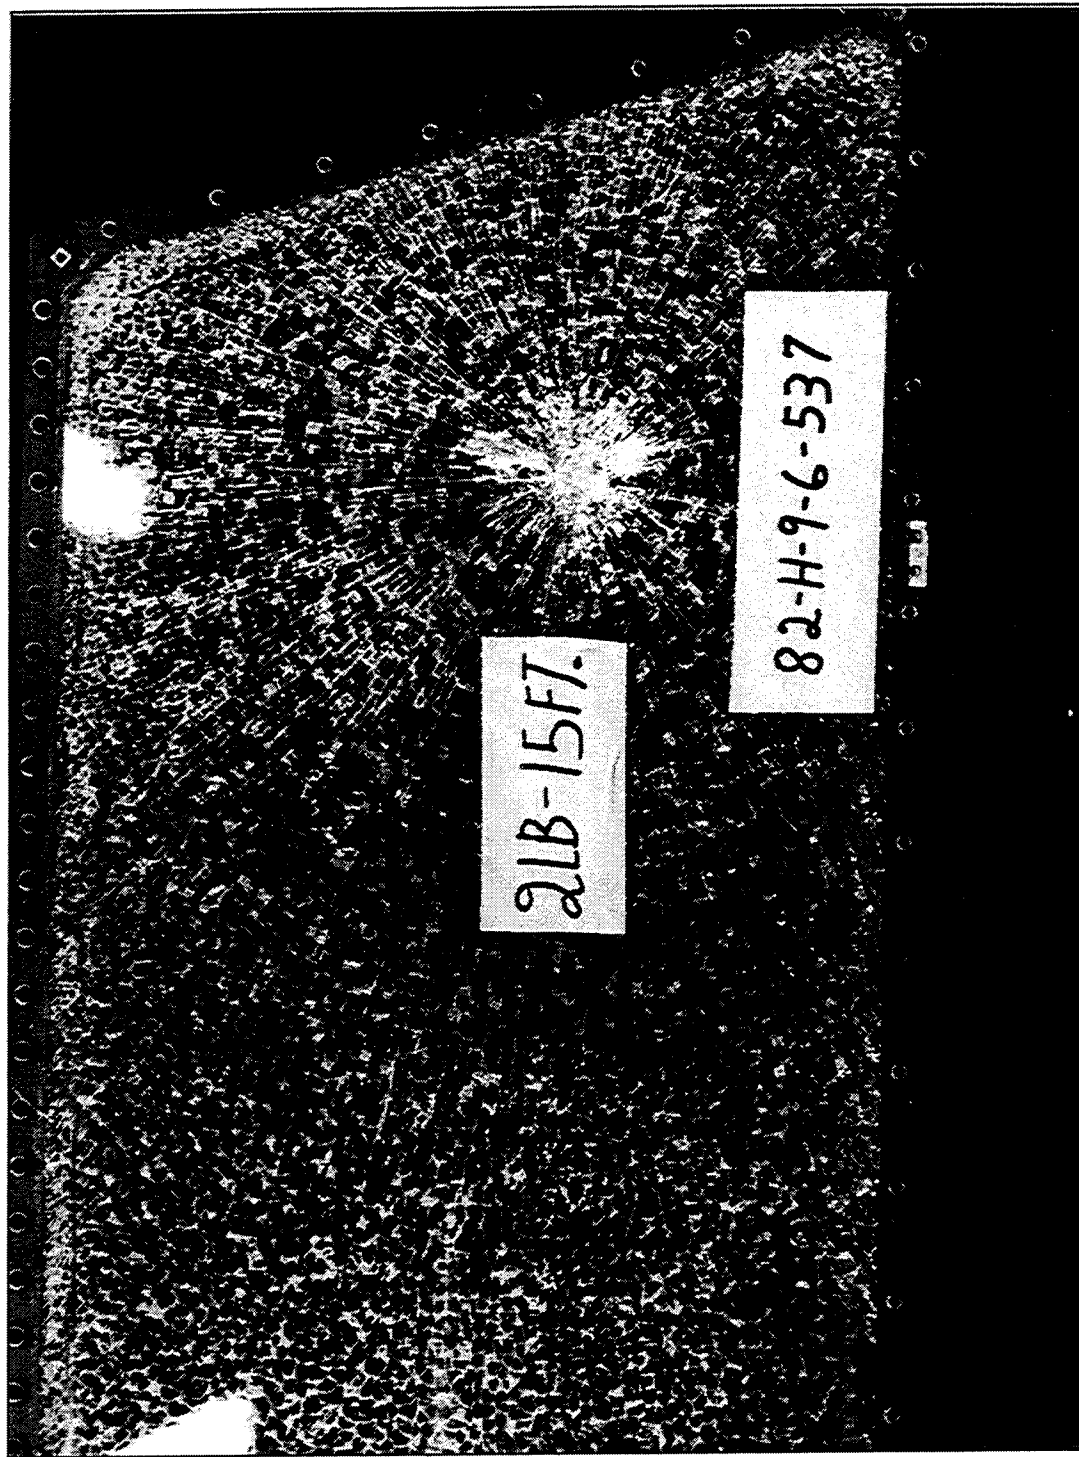
Figure 4.16 #1 W/WS Residual Strength Falling Ball Impact Test Result for a Repaired and Subsequently Delaminated W/WS, Single Ball Drop, Inboard View (S/N 82-H-9-6-537)

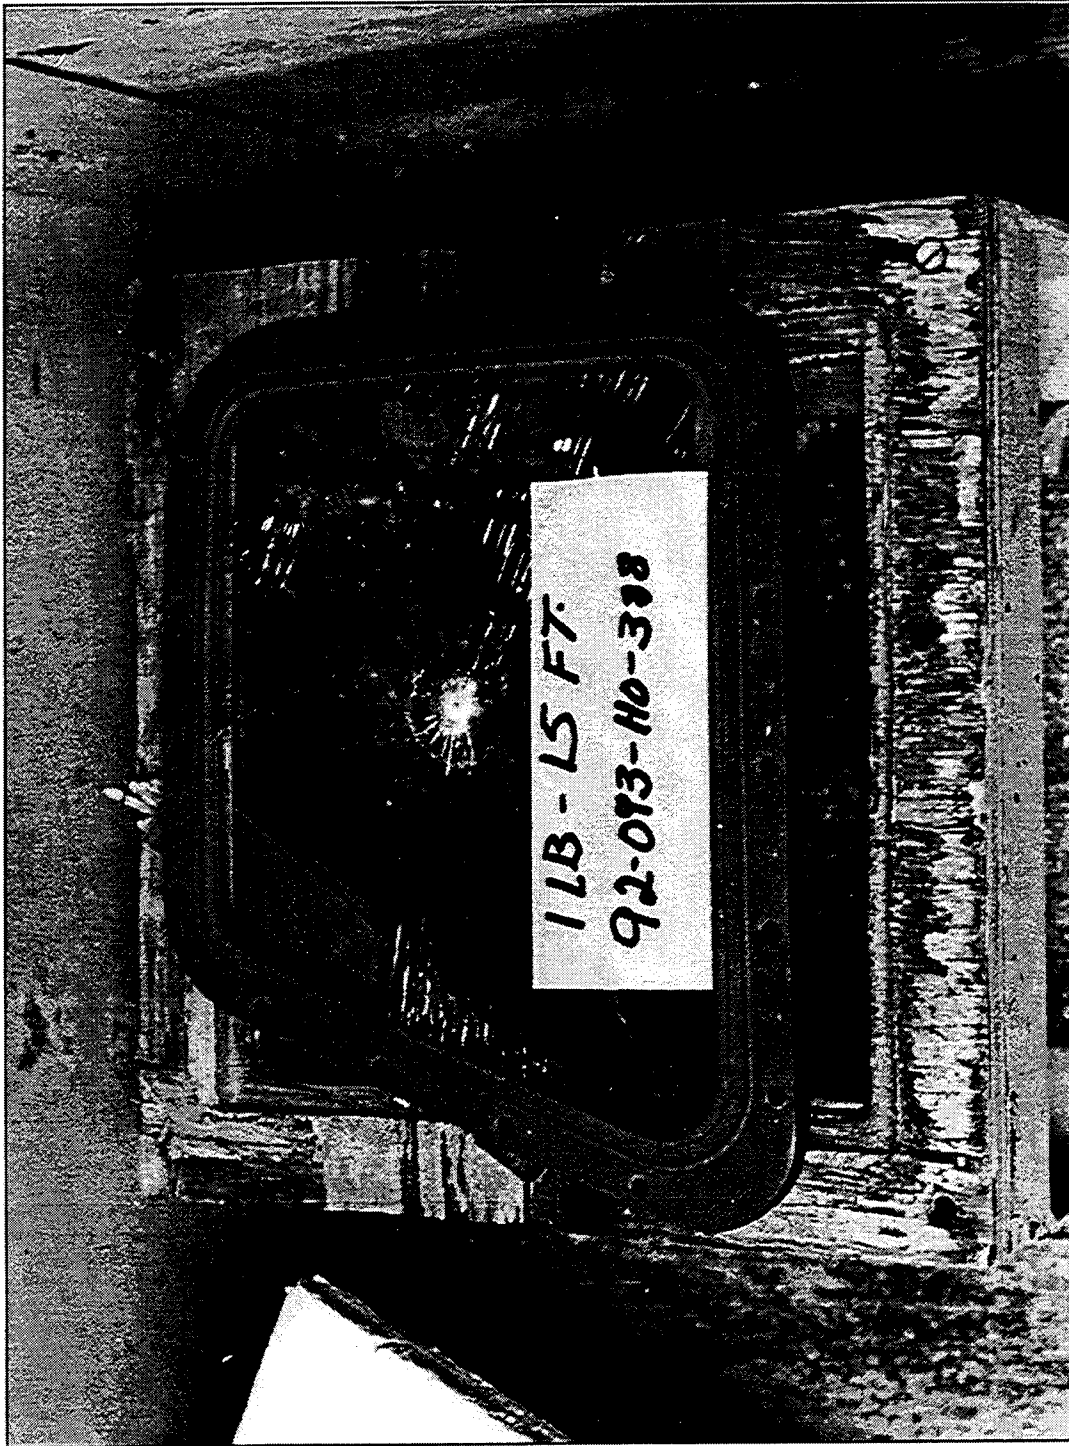
Figure 4.17 #4 W/WS Residual Strength Falling Ball Impact Test Showing Test Set Up and Test Result  
(New W/WS, S/N 92-093-HO-388)

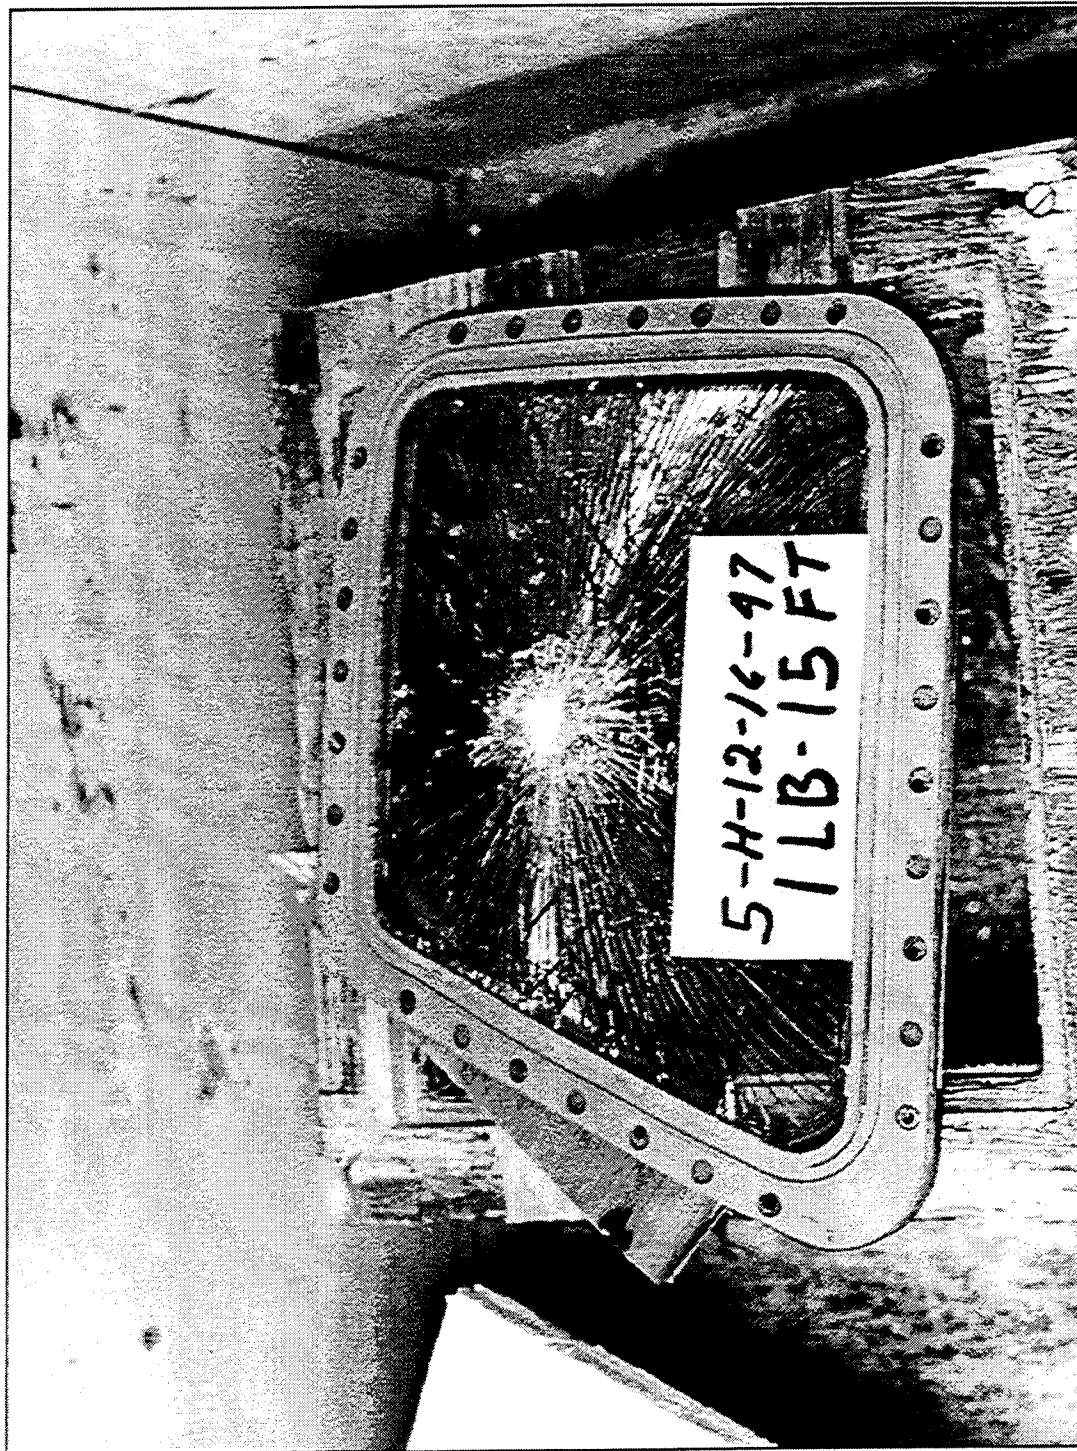
Figure 4.18 #4 W/WS Residual Strength Falling Ball Impact Test Result for a Repaired and Subsequently Delaminated W/WS, Outboard View  
(S/N 5-H-12-16-47)

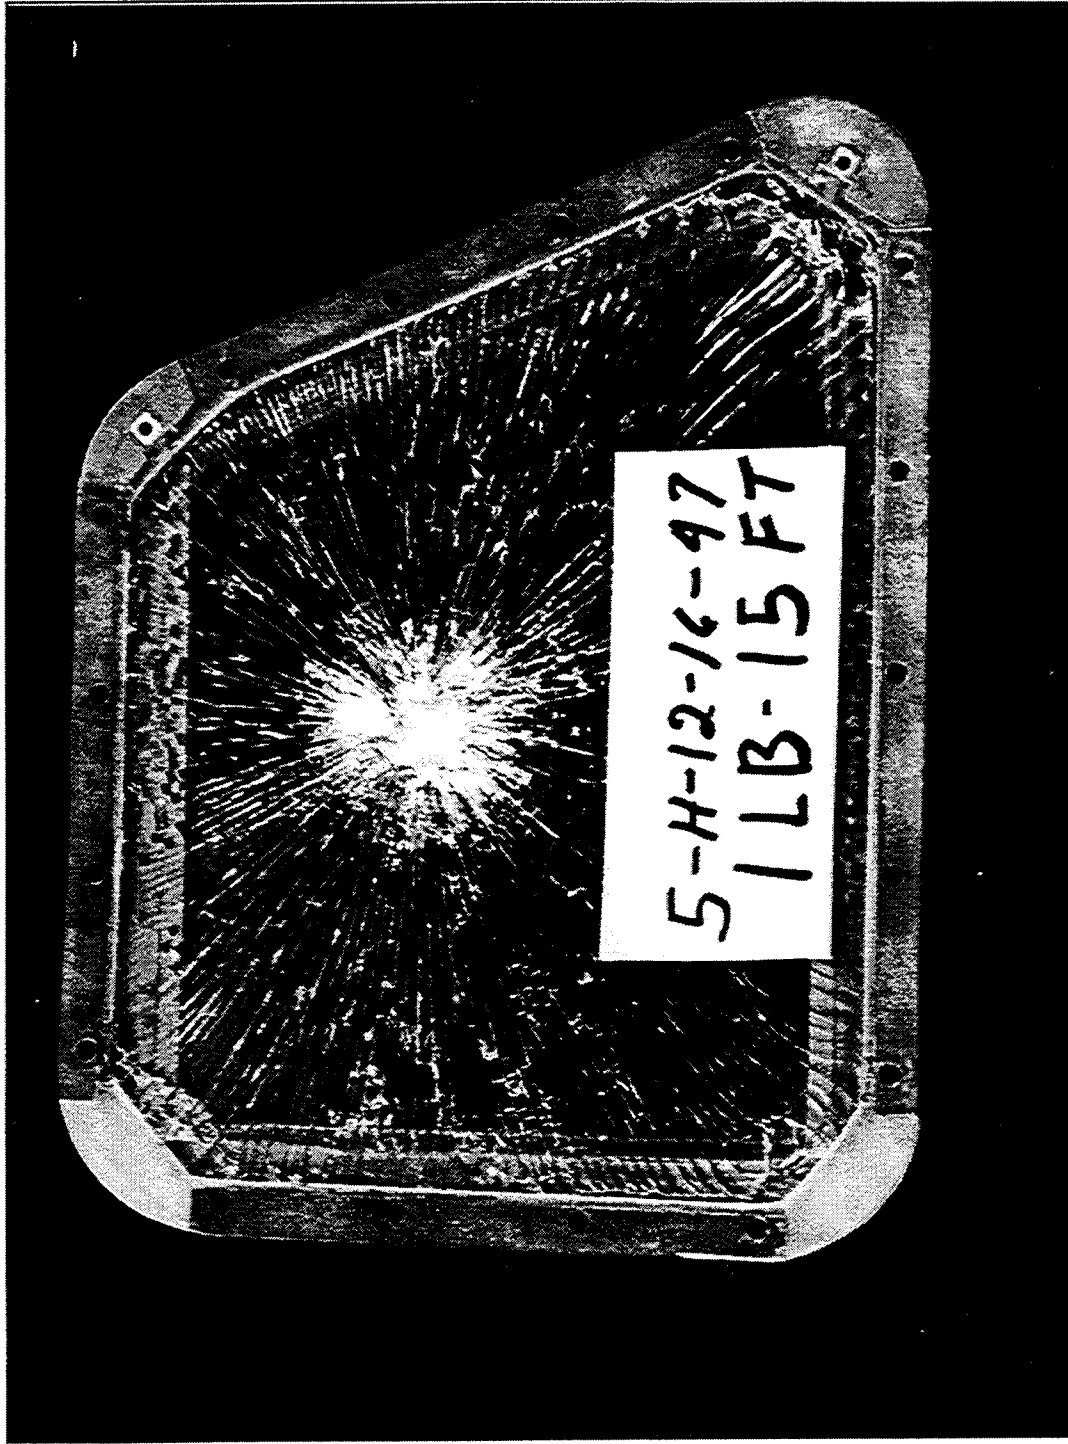
Figure 4.19 #4 W/WS Residual Strength Falling Ball Impact Test Result for a Repaired and Subsequently Delaminated W/WS, Inboard View  
(S/N 5-H-12-16-47)

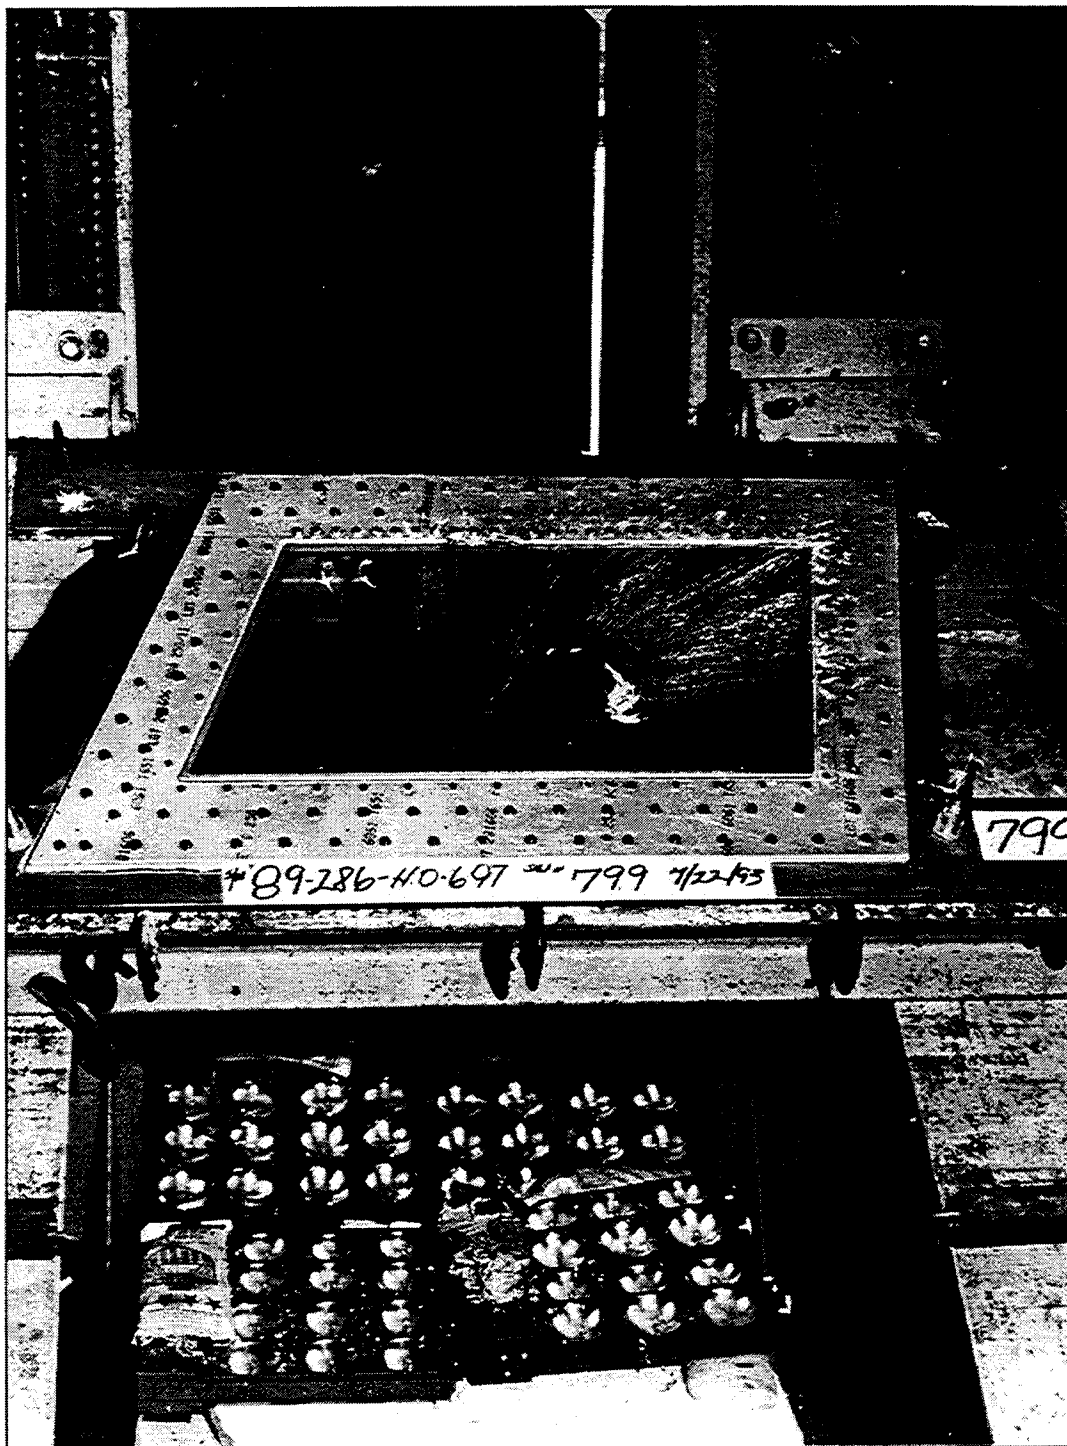
Figure 4.29 C/KC-135 #1 W/WS Showing No Damage From a 4-Pound Bird Impact at 250.8 Knots (Repaired W/WS, S/N 89-286-HO-697)

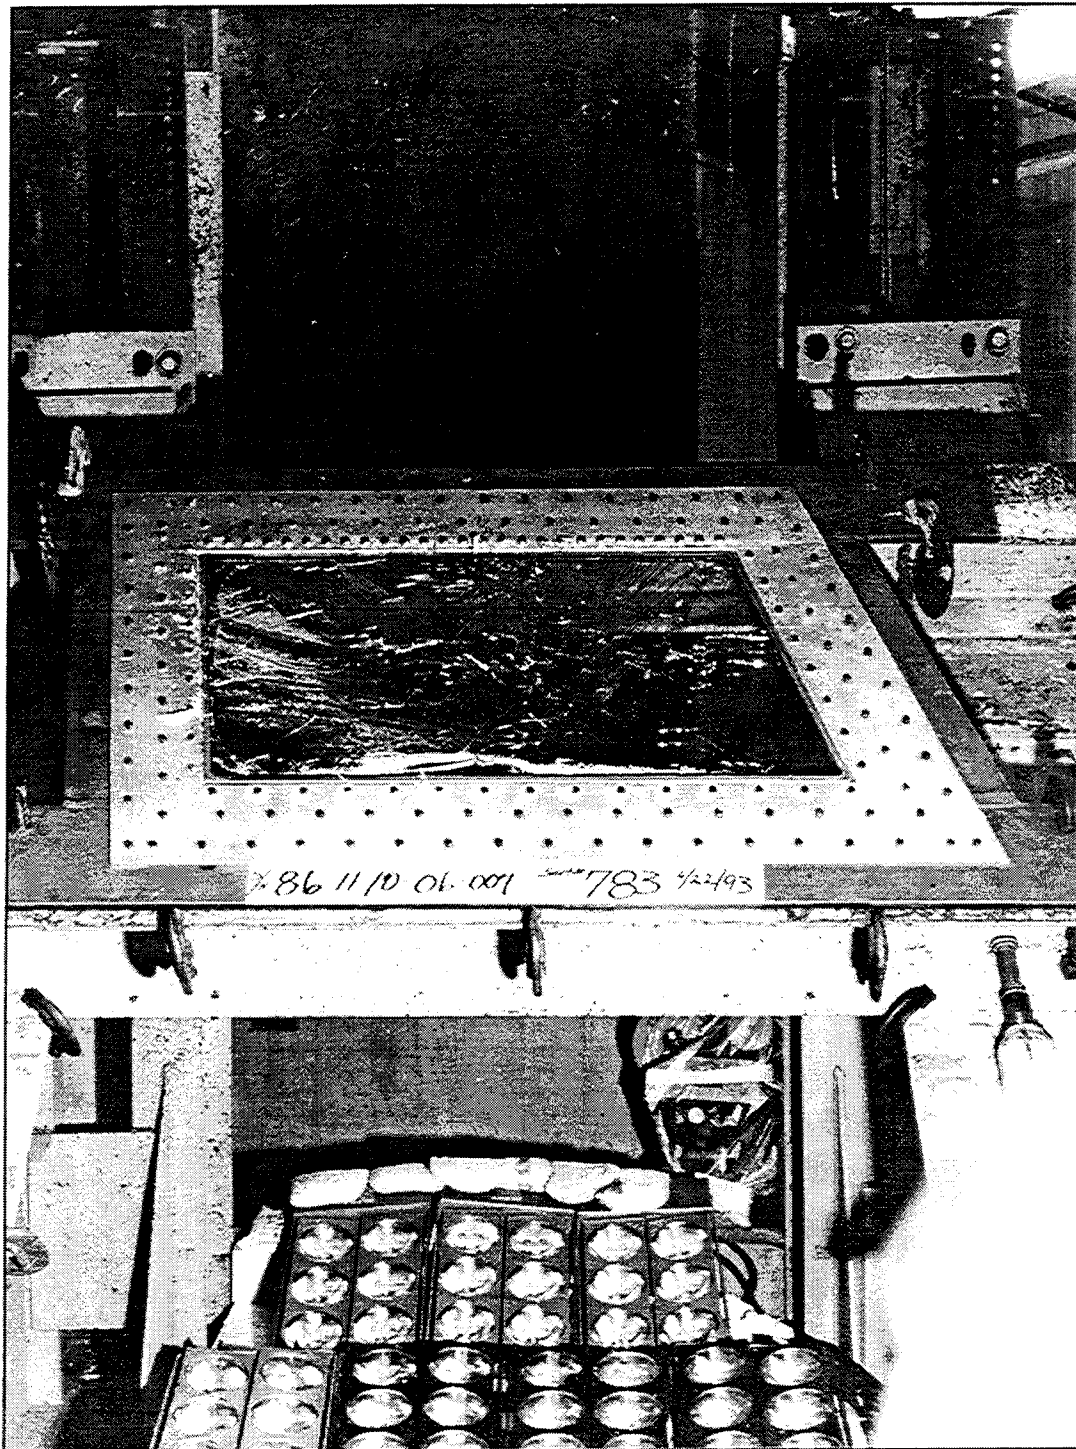
Figure 4.30 C/KC-135 #1 W/WS Showing Outboard Ply Failure From a 4-Pound Bird Impact at 251.7 Knots, Front View (New W/WS, S/N 86-H-10-06-007)

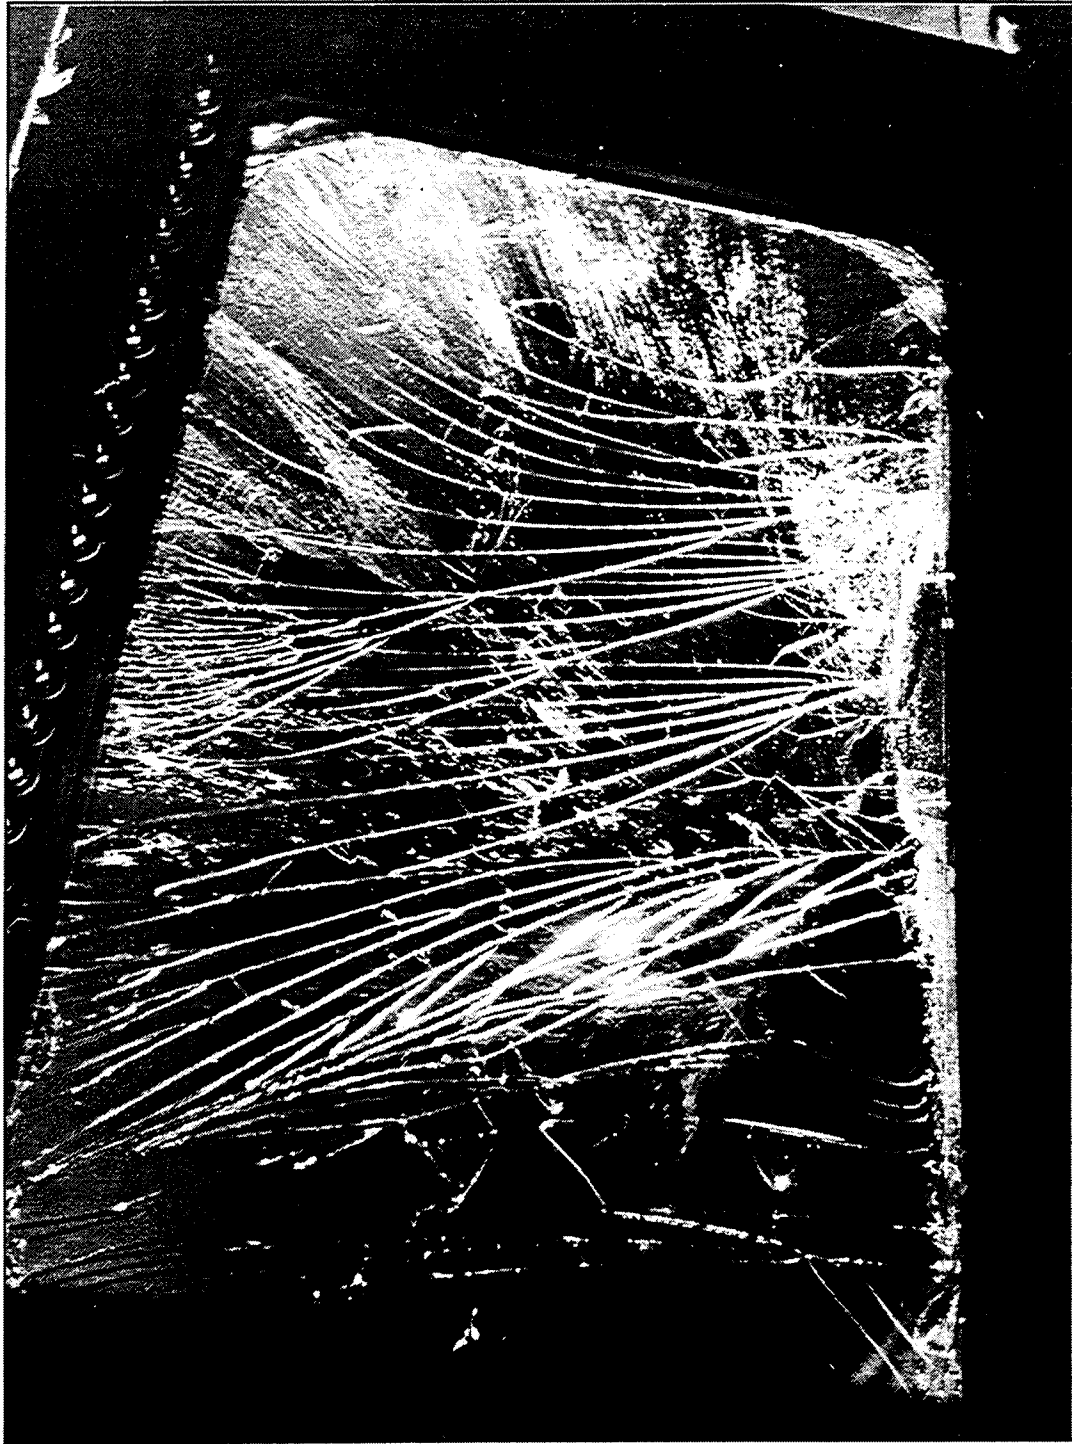
Figure 4.31 C/KC-135 #1 W/WS Showing Outboard Ply Failure From a 4-Pound Bird Impact at 251.7 Knots, Rear View  
(New W/WS, S/N 86-H-10-06-007)

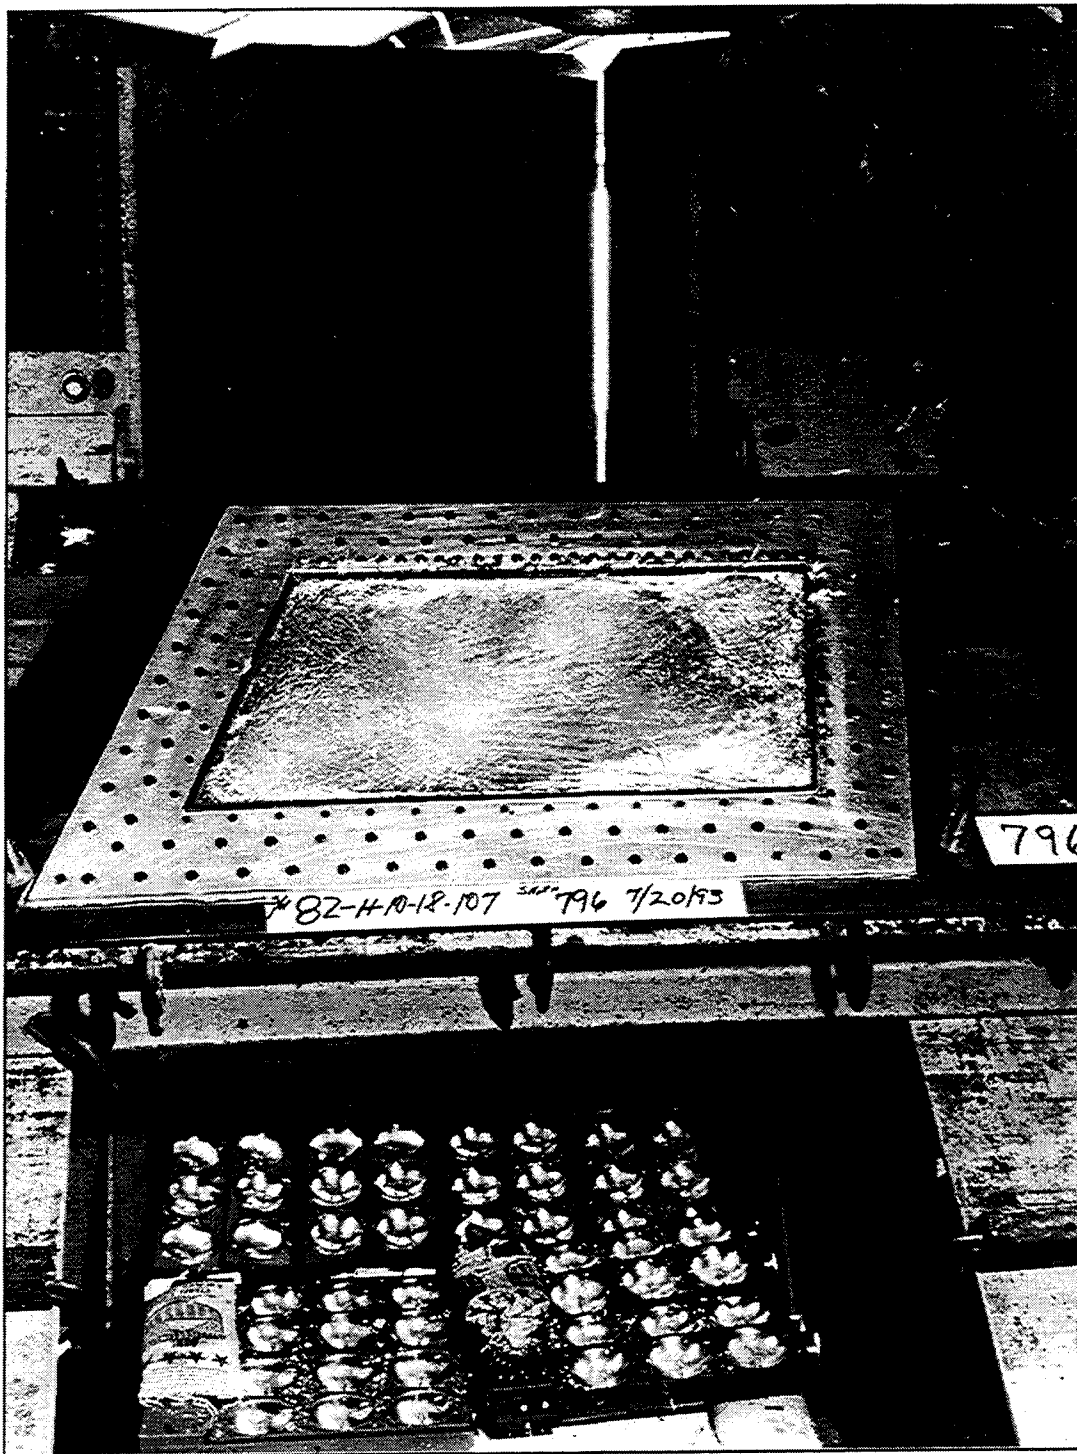
Figure 4.32 C/KC-135 #1 W/WS Showing All Glass Plies Failed From a 4-Pound Bird Impact at 249.4 Knots, Front View (Repaired W/WS, S/N 82-H-10-18-107)

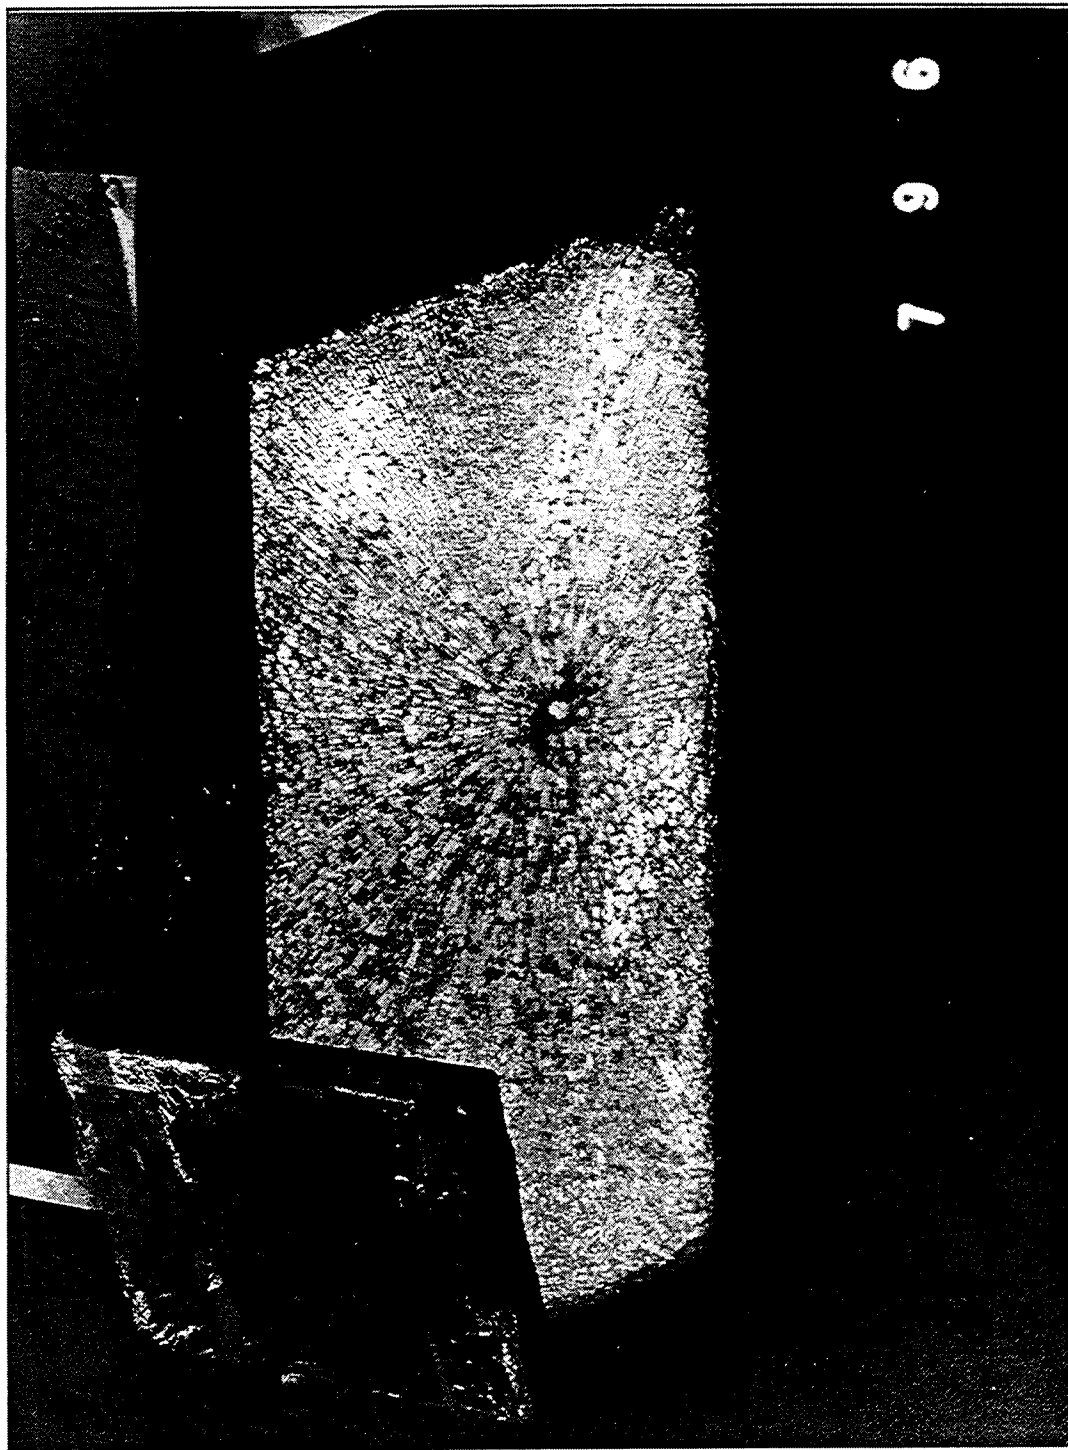
Figure 4.33 C/KC-135 #1 W/WS Showing All Glass Plies Failed From a 4-Pound Bird Impact at 249.4 Knots, Rear View  
(Repaired W/WS, S/N 82-H-10-18-107)

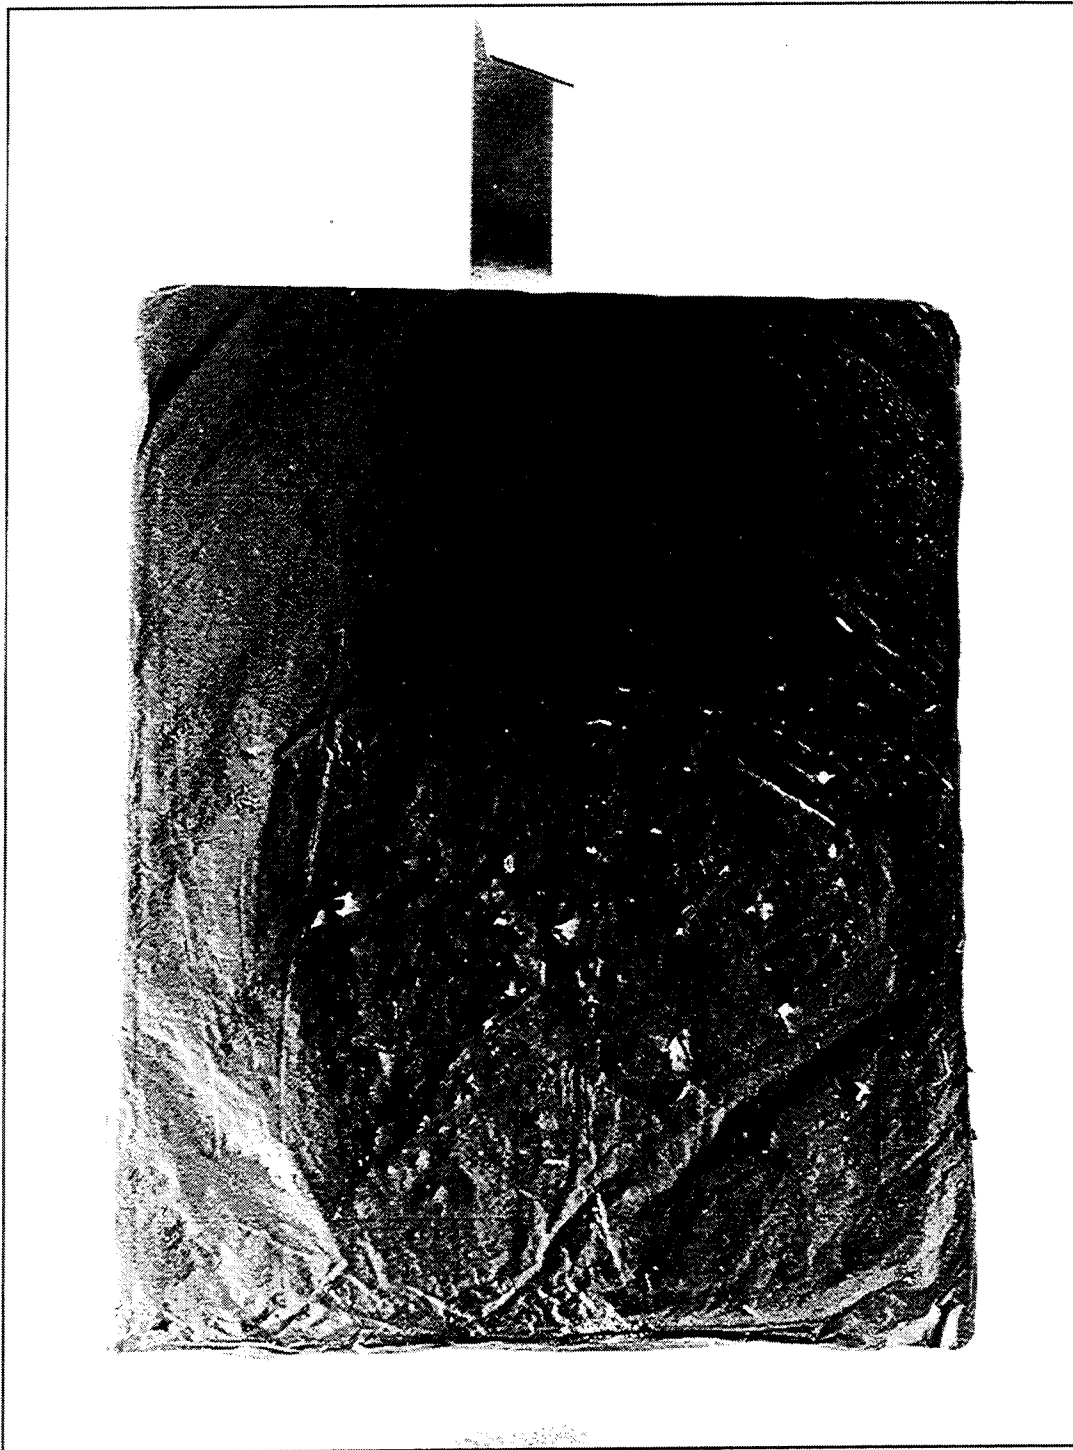
**Figure 4.34 Spall Sheet Condition From a 4-Pound Bird Impact at 249.4 Knots on a C/KC-135 #1 W/WS With All Glass Plies Failed (Repaired W/WS, S/N 82-H-10-18-107)**

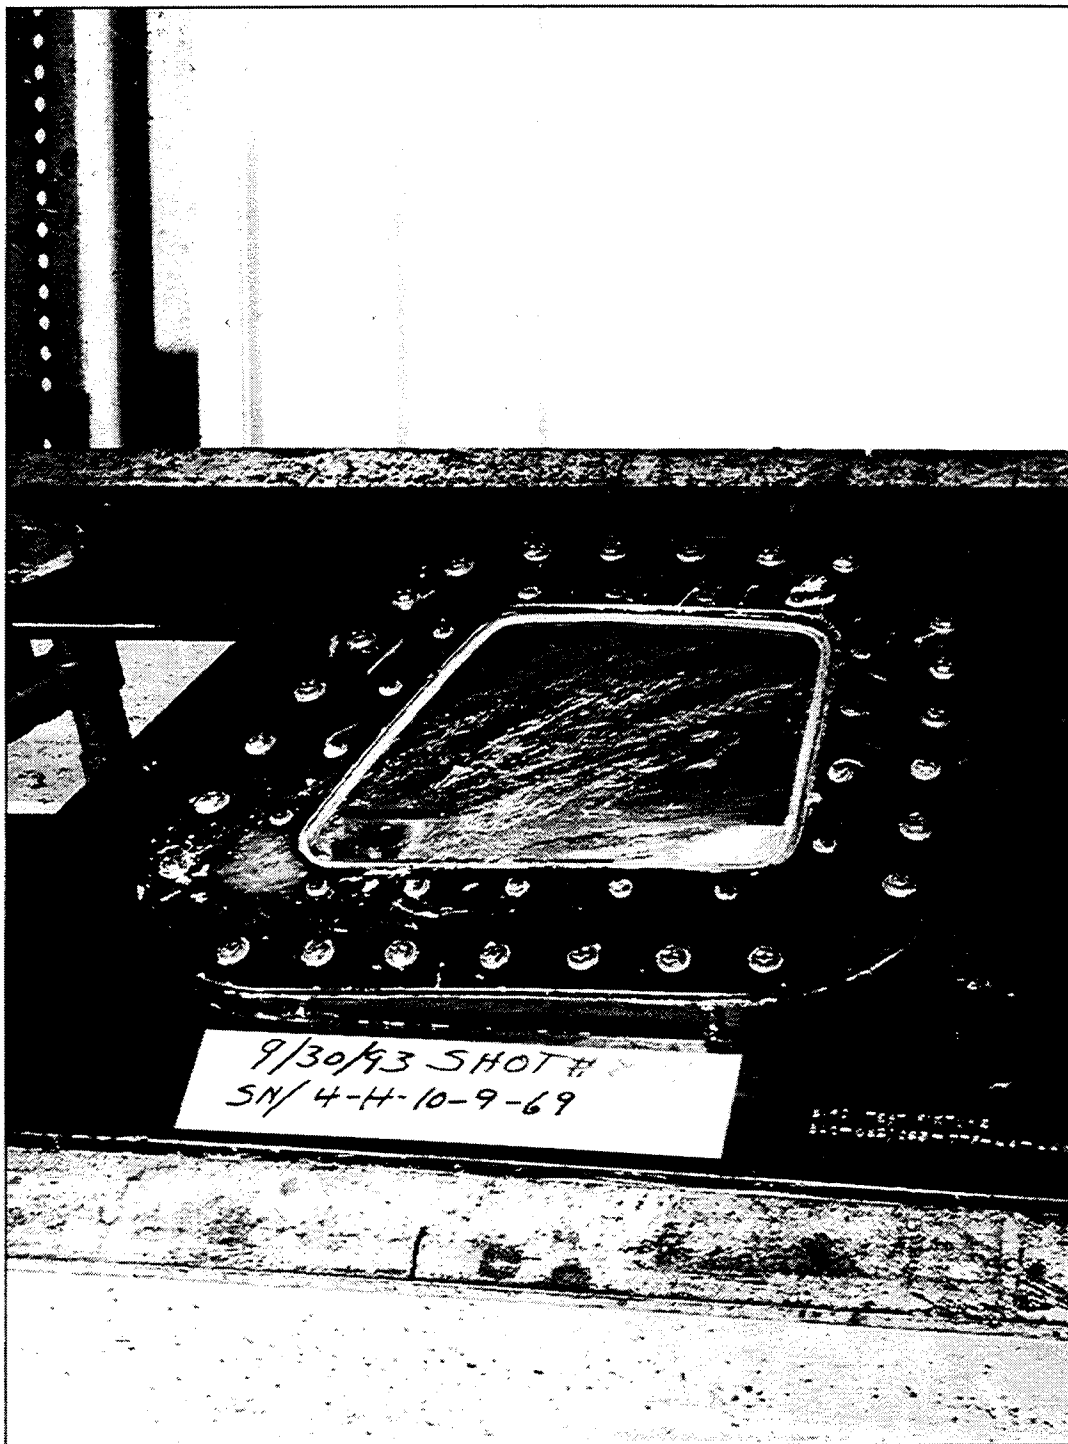
Figure 4.35 C/KC-135 #4 W/WS Showing No Damage From a 4-Pound Bird Impact at 248.7 Knots (Not Repaired W/WS, S/N 4-H-10-9-69)

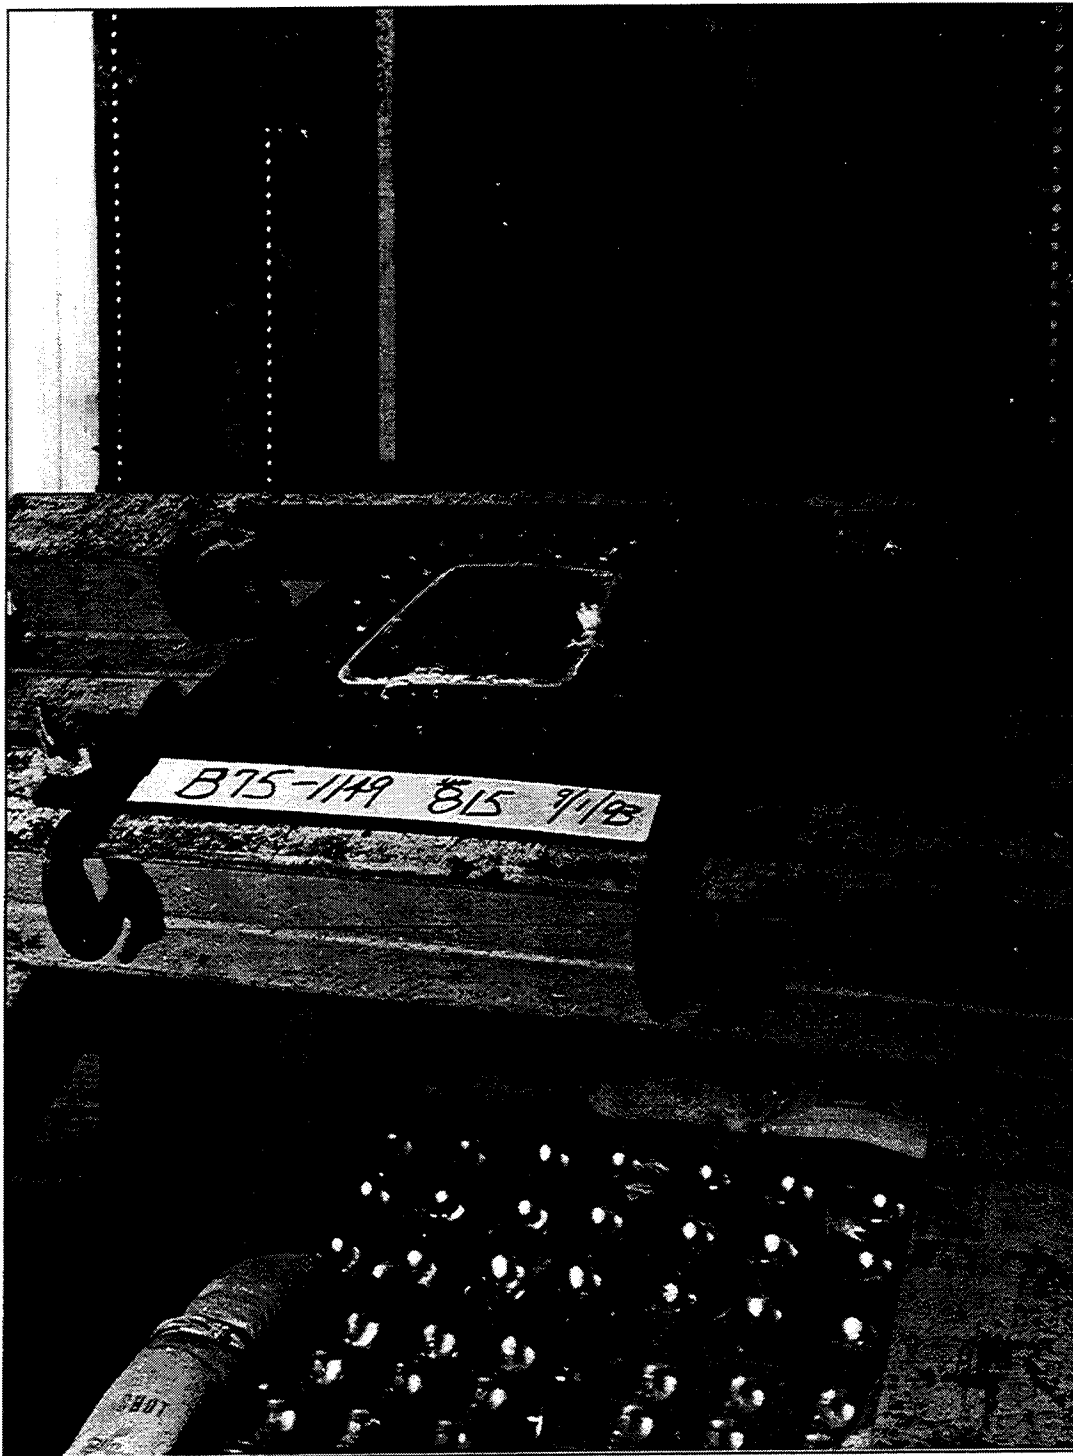
Figure 4.36 C/KC-135 #4 W/WS Showing Outboard Ply Failure From a 4-Pound Bird Impact at 247.5 Knots, Front View (Repaired W/WS, S/N B75-1149)
